POLYMER CONCRETE REPAIR OF TRENCH

CPD-1026

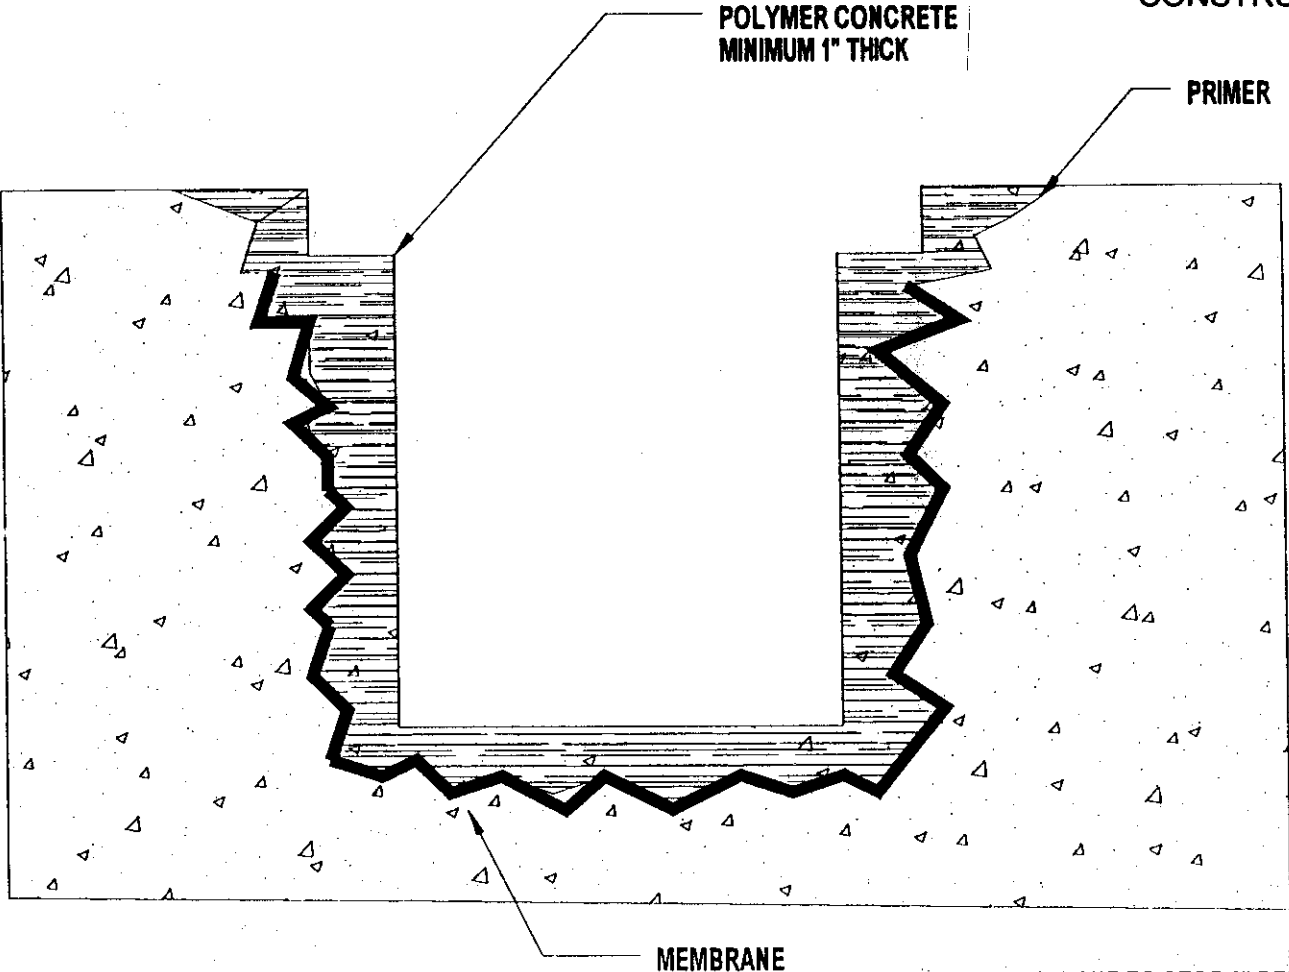
NOTE: MEMBRANE TO STOP 2" BELOW TOP
SURFACE OF CONCRETE FLOOR.
USE APPROPRIATE PRIMER FOR TOP 2".
